# RESEARCH LABORATORY TECHNICAL REPORT

## Sidewalk Repair Near Trees

By The Bartlett Lab Staff  
Directed by Kelby Fite, PhD

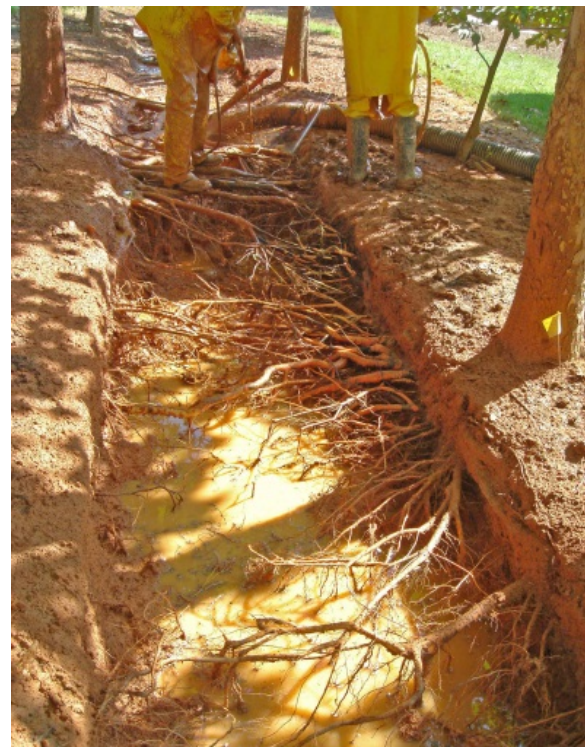
**Figure 2: Bartlett Lab research plot showing different root growth patterns with no base layer (upper) and where foam board was installed**

Modifications that will extend the useful life of sidewalk pavement include installation of root barriers alongside the pavement or installing a root-excluding base beneath the concrete (Figure 2). Root barriers must be at least 18 inches (45 cm) deep and the top must be above the soil and mulch surface to be effective. Base layers that successfully exclude roots include washed coarse gravel (1-1.5 inches, 2.5-3.7 cm diameter, with no fines) and foam insulation boards. A gravel base at least 4 inches (10 cm) thick is recommended; thicker is probably better. Gravel is only effective in well drained soils. Foam boards are commonly available from ½ to 2 inches (1.25 to 5 cm) thick. Two 2 inch (5 cm) thick boards can be glued together to provide a 4 inch (10 cm) base for the greatest protection from root growth damage.

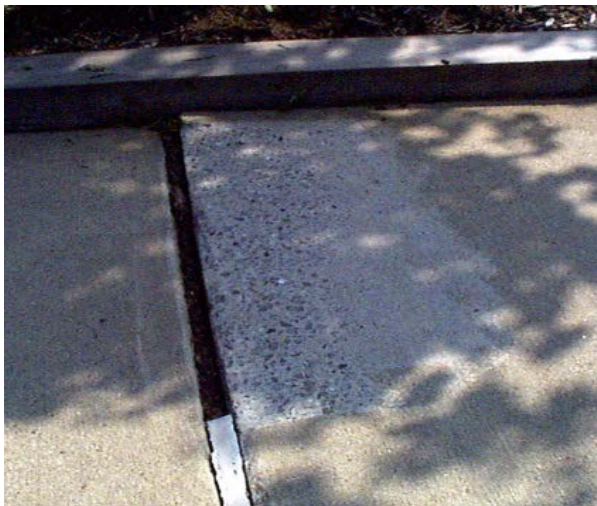
**Figure 3: Concrete shaved/ground to smooth**

**1. Shaving the top of the concrete or installing a ramp** to even the surface and reduce the tripping hazard (Figure 3). Shaving or grinding the concrete is done with a specialized cutting machine. The goal is to lower the raised concrete edge to the level of the lower slab. Concrete can be ground to about ½ of its original thickness. The other commonly used alternative is to install a ramp or wedge of asphalt or concrete to smoothly bring the lower level up to the lifted edge (Figure 4).

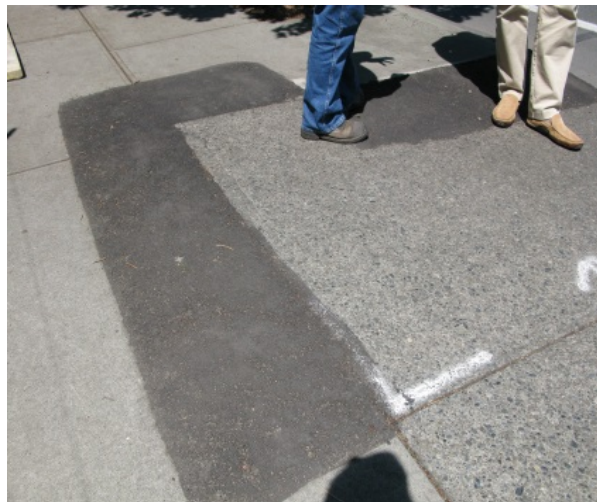
**Figure 4: Asphalt ramp/wedge installed to reduce tripping hazard**

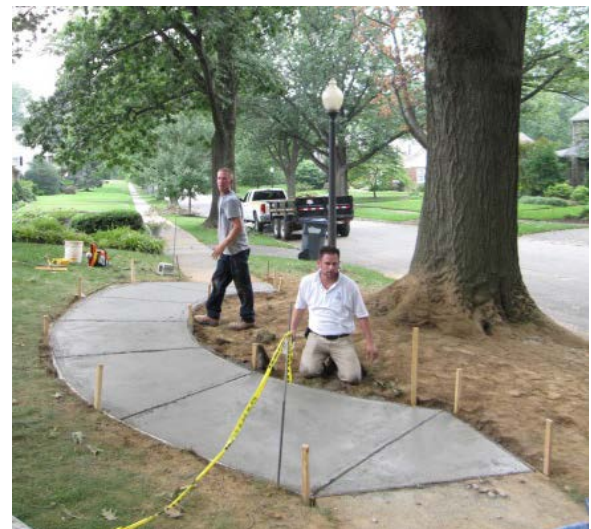
**Figure 5: Sidewalk rerouted to increase the distance from the trunk and avoid root damage**

**2. Increasing the distance from the tree to the edge of the sidewalk.** This can be done by either narrowing the sidewalk or rerouting it around the tree. The Americans with Disabilities Act (ADA) limits sidewalk width to no less than 39 inches (1m). By increasing the distance from the sidewalk to the trunk, the roots that are most likely to cause damage will no longer be underneath the pavement. Sidewalks can often be curved around a tree with the permission of the property owner (Figure 5). These techniques can avoid damage to large roots that are primarily responsible for tree stability.

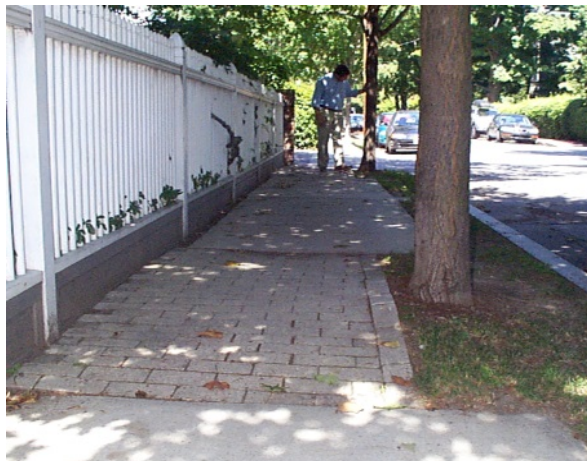
**Figure 7: Sidewalk narrowed and pavers installed to provide more room for root growth**

**4. Replacing concrete with interlocking paver blocks or rubber pavers** (Figure 7). This alternative will not slow pavement lifting, but will allow for a smoother transition and the removal of blocks that have lifted too high. Pavers are installed by removing the concrete and base materials above the roots and removing the soil between the roots (if needed) using a supersonic air excavation tool, installing a new sub-base of coarse sand or pea gravel and leveling and compacting the sub-base slightly above the existing roots. Next, install a geotextile fabric (e.g. Typar 3341) on top of the base, install and compact a coarse sand base layer, and finally, install the pavers. Paver joints should *not* be mortared.

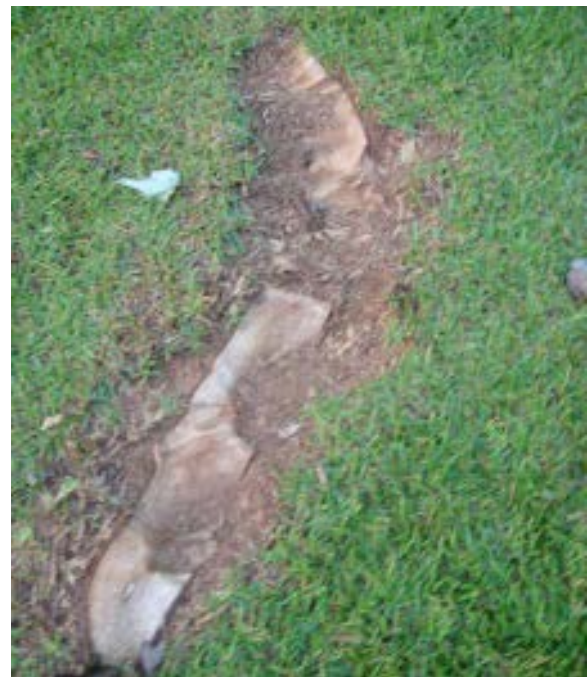
**Figure 8: Root top shaved to lower the surface**

**5. Root shaving then installing new concrete.** If the pavement must be reinstalled flat and in the same location from which it was removed, the height of the offending roots will need to be lowered. For mature trees, it is best not to cut roots greater than 2 inches (5 cm) in diameter. However, it is usually roots that are larger than this that create sidewalk lifting problems. It is better to remove the top surface of a root rather than the entire root (Figure 8). This is done by shaving the root using a chainsaw or debarking tool. Large roots should not be cut more than 1/3 of their diameter. Cut roots do tend to callus quickly, so a layer of rigid foam or pipe insulation foam should be installed between the shaved root surface and the new concrete. The loss of tree stability from root shaving and the rate of decay in shaved roots are not known. The tree should be inspected annually for health and stability if shaving is done closer than three times the trunk diameter (DBH) from the base of the tree.

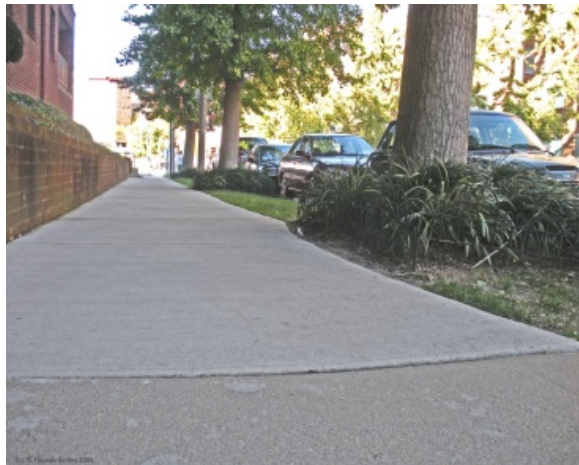
**Figure 9: This new smooth and level sidewalk required root cutting within 1.5 times trunk diameter.**

**6. Root removal and sidewalk replacement.** The removal of roots at the edge of the sidewalk followed by concrete replacement will provide a longer term solution to sidewalk lifting but will have the greatest effect on tree health and stability. A thorough tree structural analysis should be

conducted before roots are removed. It is recommended that buttress roots not be cut closer to the trunk than a distance equal to three times the trunk diameter (DBH). If they need to be severed closer than 1.5 times trunk diameter, tree removal should be considered since it is very likely that tree stability will be affected at this distance, depending on tree species and condition (Figure 9). When reinstalling the pavement next to a root cut tree, allow space for callus and trunk diameter growth. Installation of a root barrier or root-excluding base (foam board or washed gravel) should also be considered under the new pavement to avoid reoccurrence of the problem.
